The Road Inventory of Spring Creek National Fish Hatchery Underwood, WA

Prepared By:
Federal Highway Administration
Central Federal Lands Highway Division
January 2013

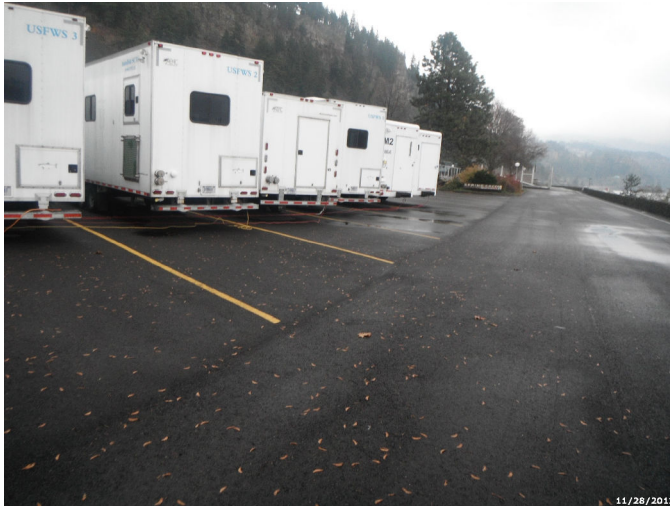
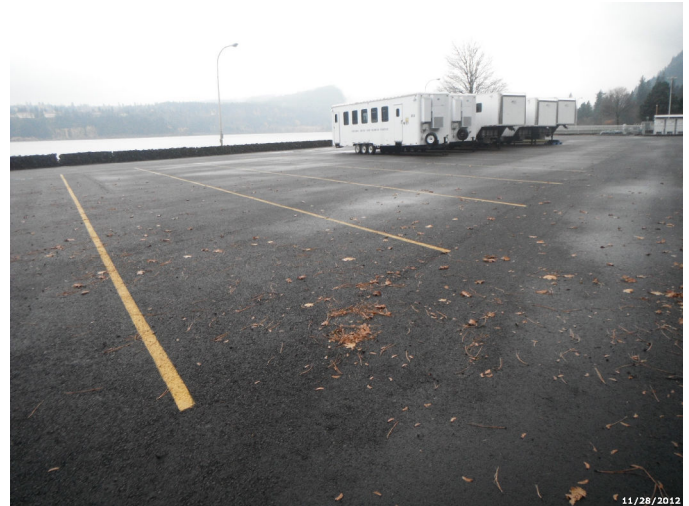
Asset Number	Area (Sq Ft)	Condition	Surface Type	Cost to Improve	Inspection Date	Current Replacement Value
10047246	11709	Excellent	Asphalt	\$0	11-28-2012	\$122,800

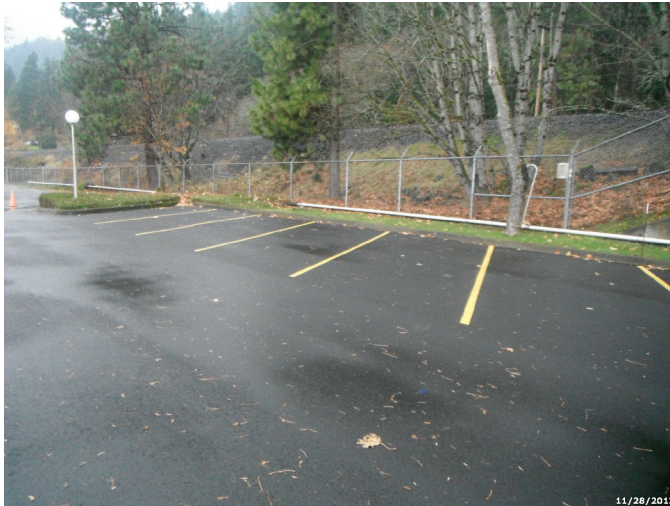
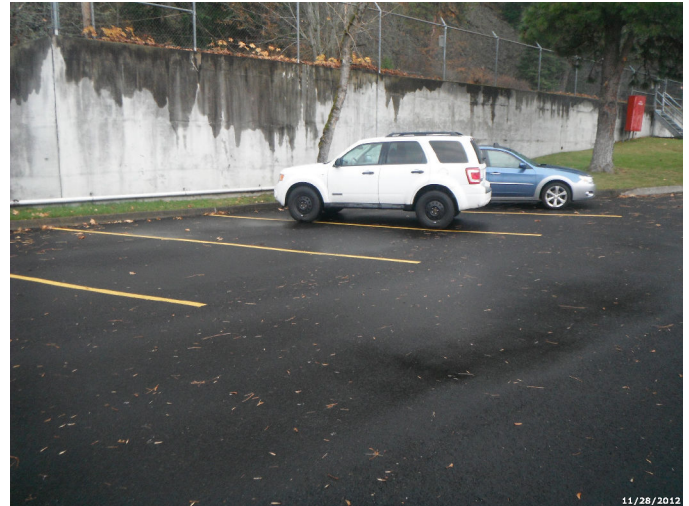
Route Number:901

Asset Number	Area (Sq Ft)	Condition	Surface Type	Cost to Improve	Inspection Date	Current Replacement Value
10047246	1938	Excellent	Asphalt	\$0	06-21-2004	\$20,300

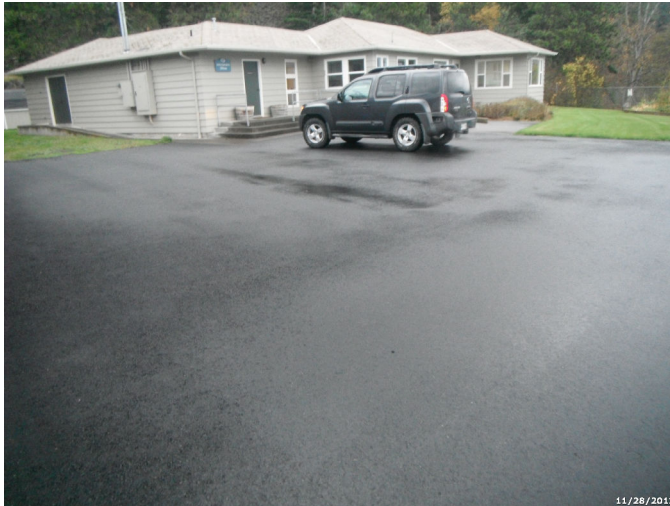
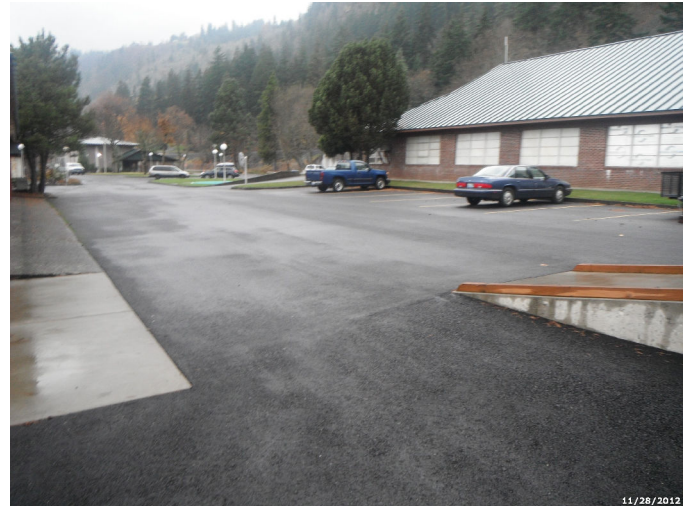
Route Number:902

Asset Number	Area (Sq Ft)	Condition	Surface Type	Cost to Improve	Inspection Date	Current Replacement Value
10047246	9734	Excellent	Asphalt	\$0	11-28-2012	\$102,100

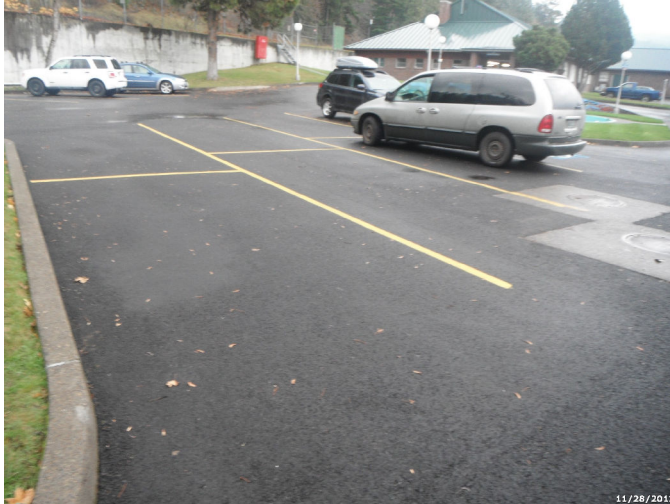
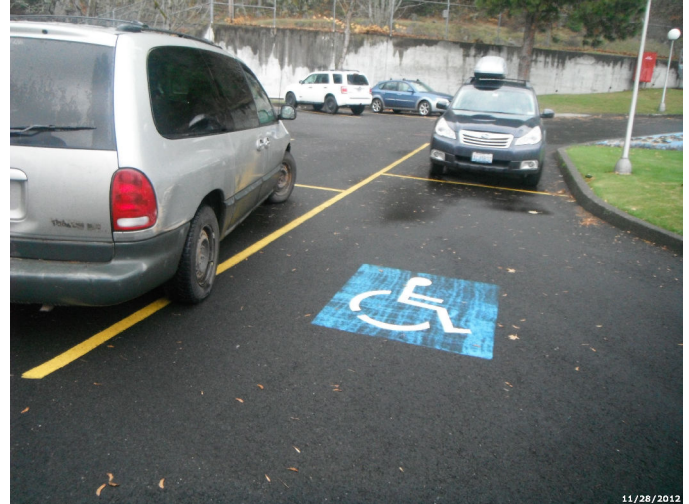
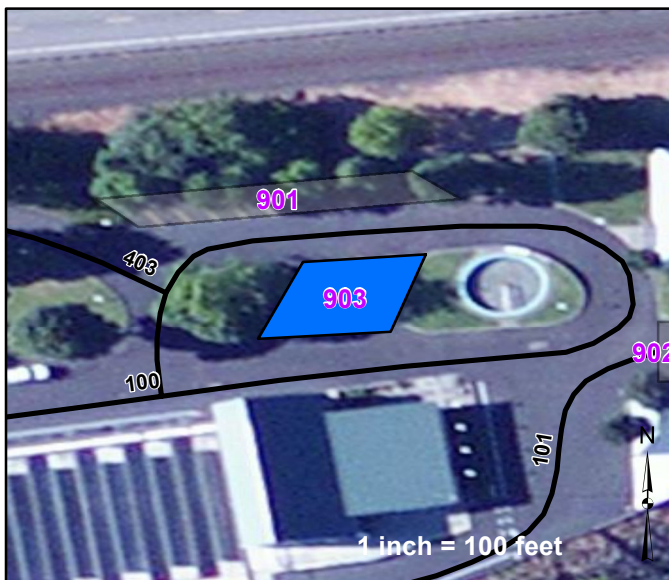
Route Number:903

Asset Number	Area (Sq Ft)	Condition	Surface Type	Cost to Improve	Inspection Date	Current Replacement Value
10047246	1808	Excellent	Asphalt	\$0	11-28-2012	\$19,000

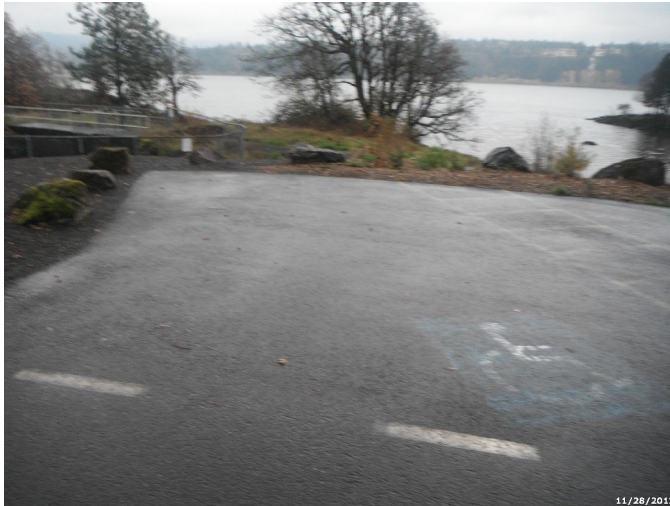
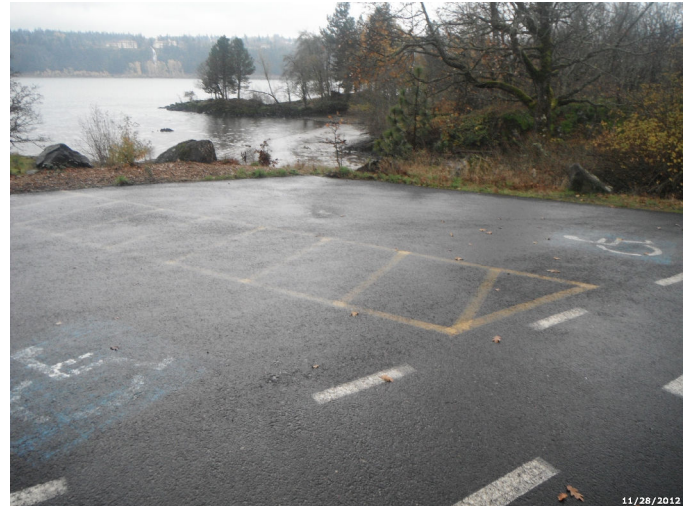
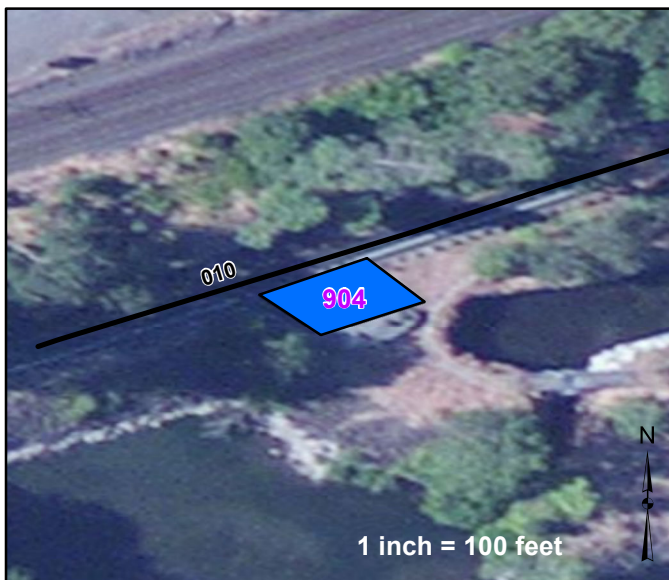
Route Number:904
Entrance Handicapped Parking
From Hatchery Entrance Road (Route 010)

Asset Number	Area (Sq Ft)	Condition	Surface Type	Cost to Improve	Inspection Date	Current Replacement Value
10047246	1227	Excellent	Asphalt	\$0	11-28-2012	\$12,900

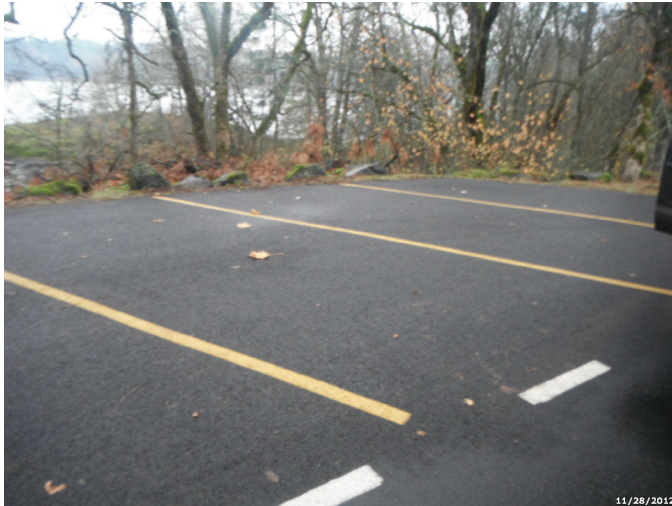
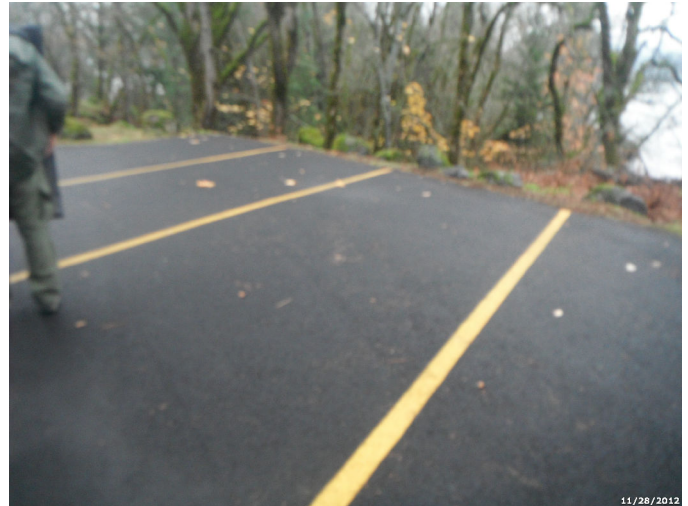
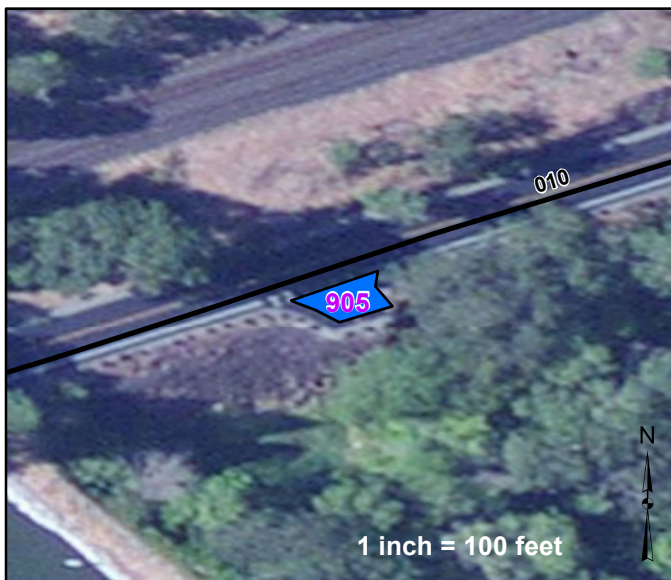
Route Number:905

Asset Number	Area (Sq Ft)	Condition	Surface Type	Cost to Improve	Inspection Date	Current Replacement Value
10047246	485	Excellent	Asphalt	\$0	11-28-2012	\$5,100

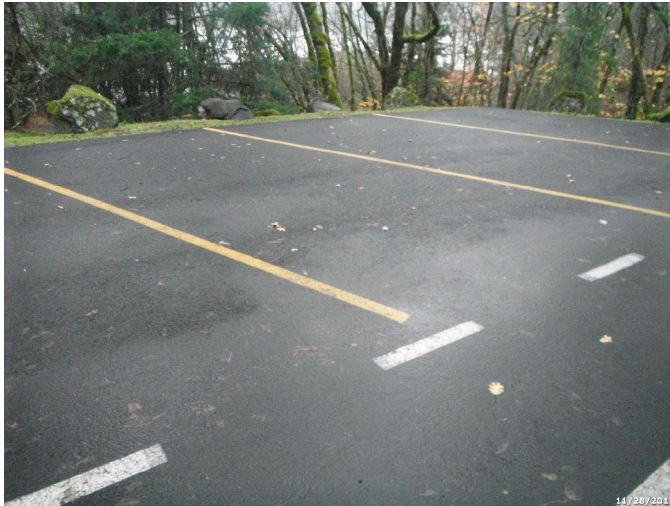
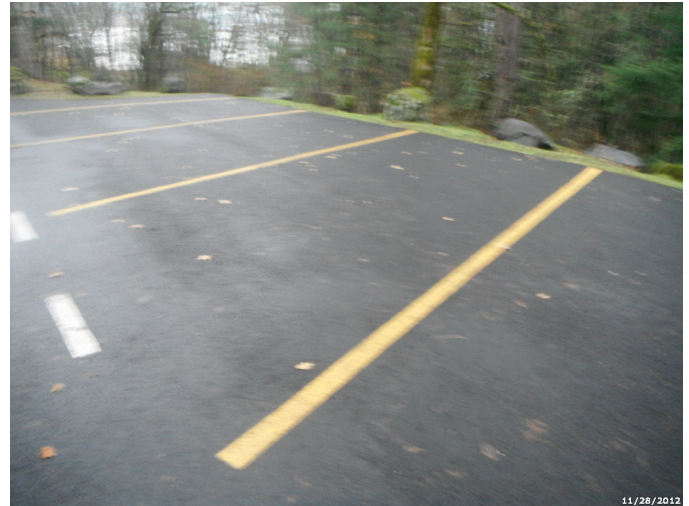
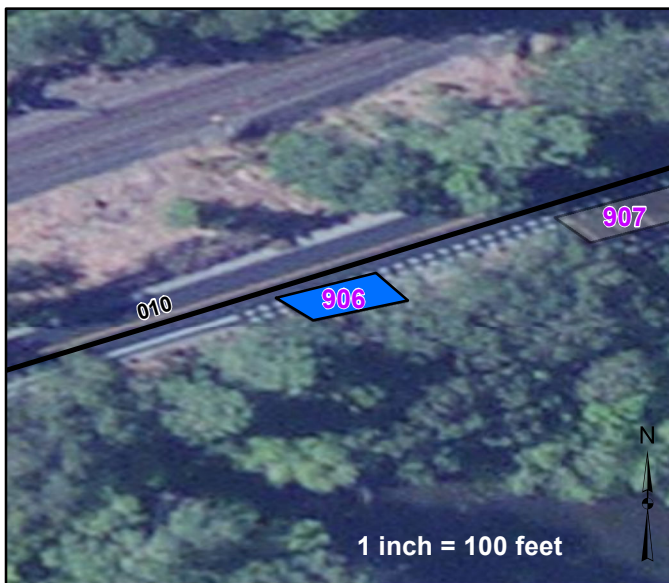
Route Number:906

Asset Number	Area (Sq Ft)	Condition	Surface Type	Cost to Improve	Inspection Date	Current Replacement Value
10047246	606	Excellent	Asphalt	\$0	11-28-2012	\$6,400

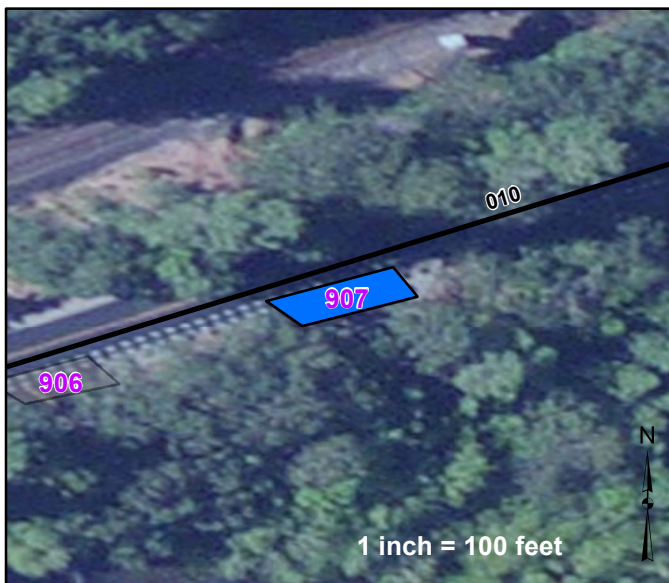
Route Number:907

Asset Number	Area (Sq Ft)	Condition	Surface Type	Cost to Improve	Inspection Date	Current Replacement Value
10047246	804	Excellent	Asphalt	\$0	11-28-2012	\$8,400

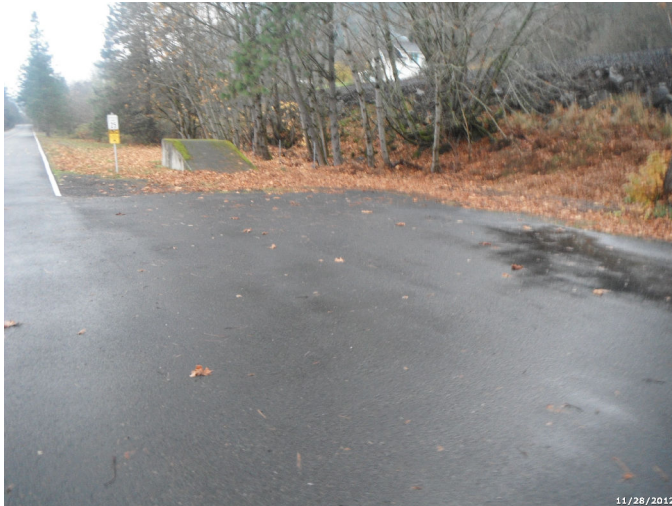
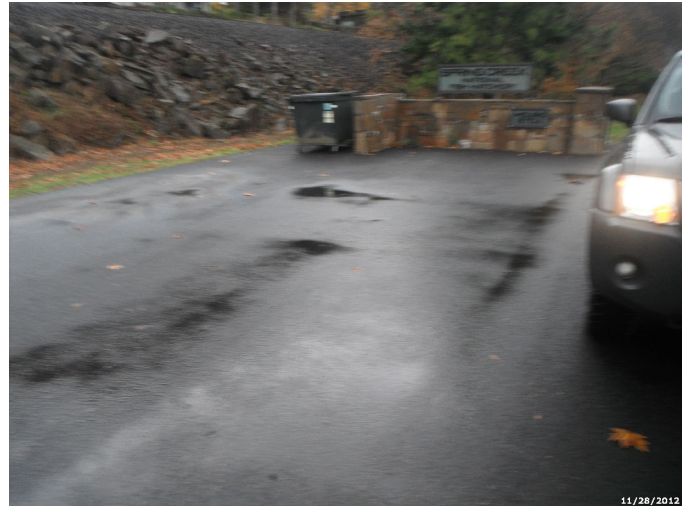
Route Number:908

Asset Number	Area (Sq Ft)	Condition	Surface Type	Cost to Improve	Inspection Date	Current Replacement Value
10047246	1930	Excellent	Asphalt	\$0	11-28-2012	\$20,200

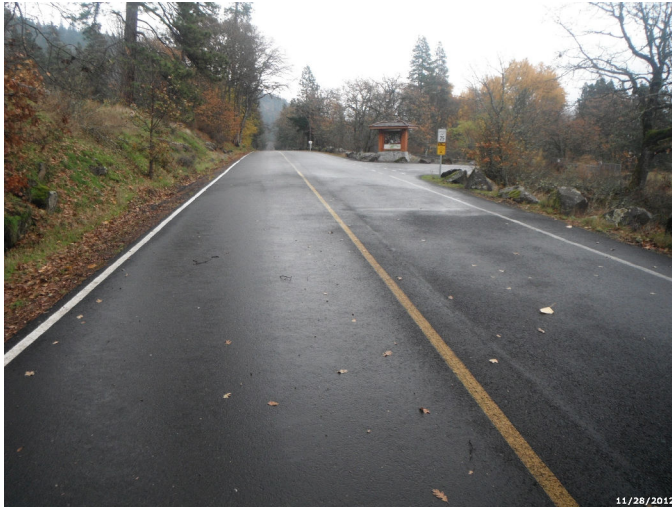
Photo: SPCR_C4_4138 Route: 010-001-0.0
Begin Section

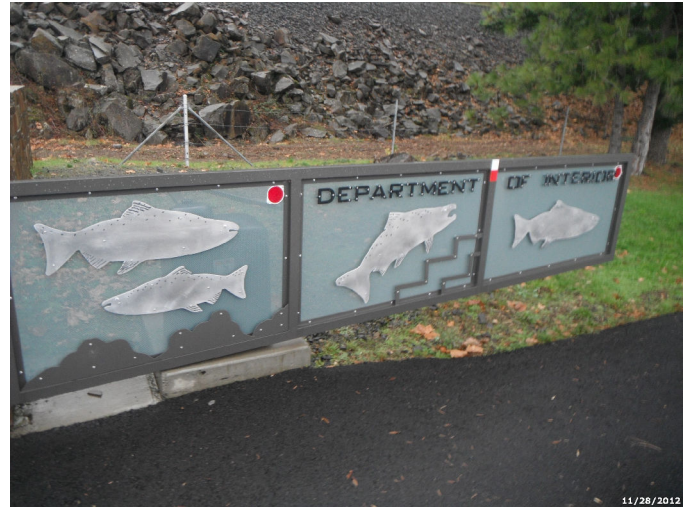
Photo: SPCR_C4_4139 Route: 010-001-0.44
Metal Open Rail Gate Electric

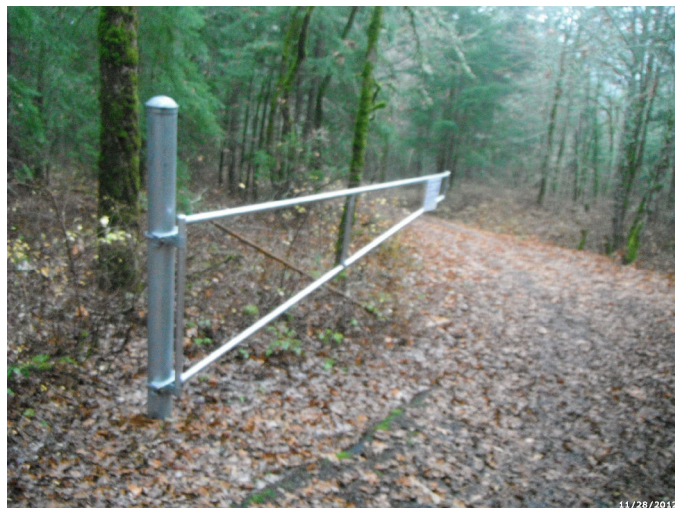
Photo: SPCR_C4_4108 Route: 400-001-0.01
Metal Open Rail Gate

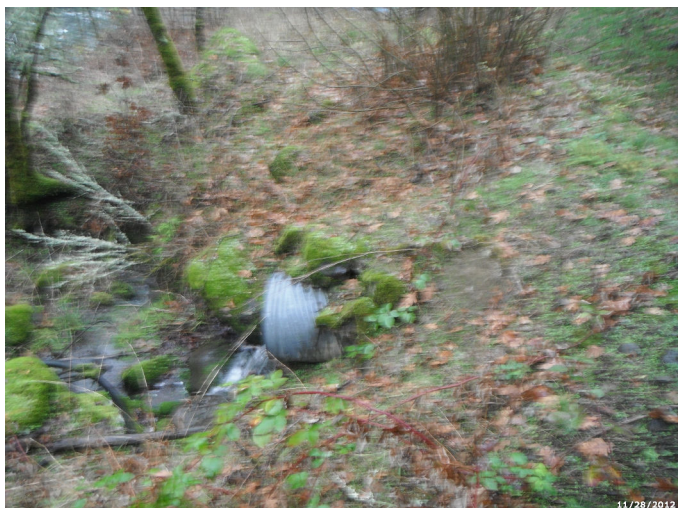
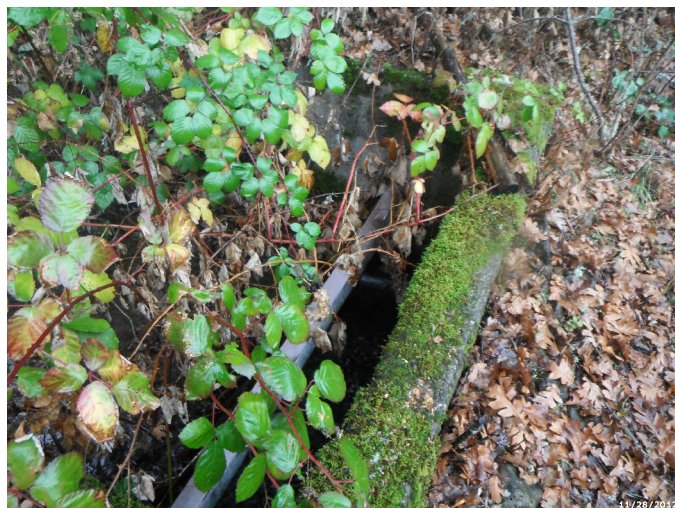
Photo: SPCR_C4_4110 Route: 400-001-0.36
Metal Culvert 25ft long 24in dia. 2ft deep

Photo: SPCR_C4_4111 Route: 400-001-0.36
Metal Culvert 25ft long 24in dia. 2ft deep

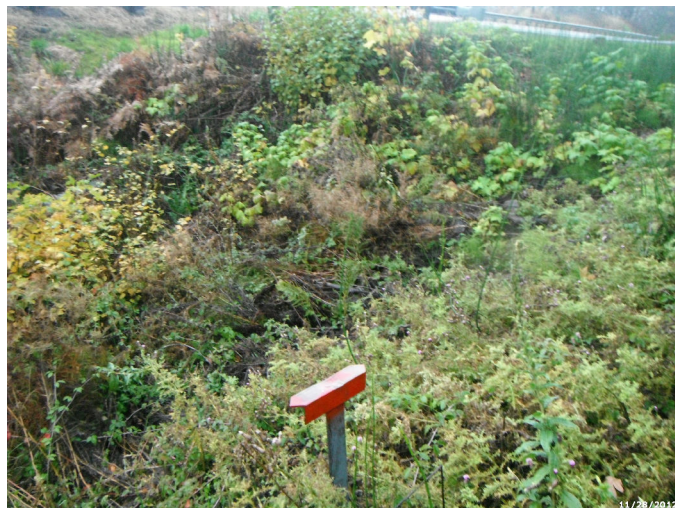
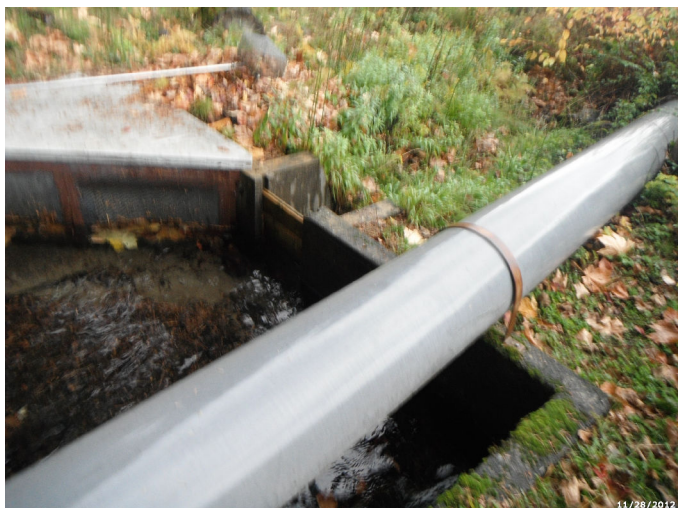
Photo: SPCR_C4_4116 Route: 401-001-0.01
Metal Culvert 40ft long 24in dia. 3ft deep

Photo: SPCR_C4_4117 Route: 401-001-0.01
Metal Culvert 40ft long 24in dia. 3ft deep

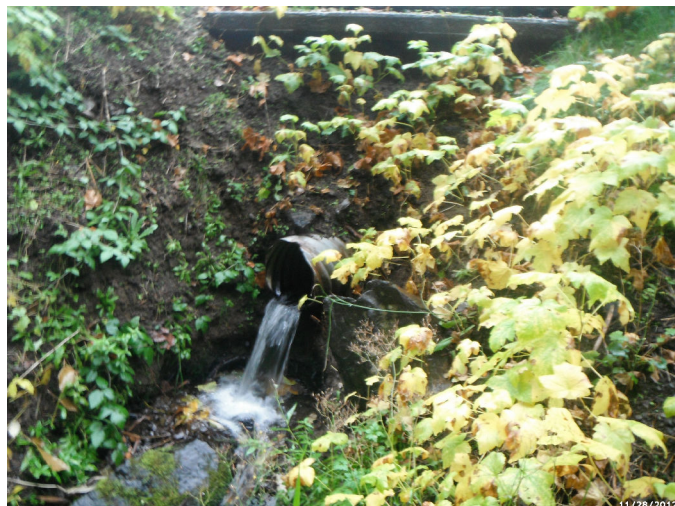
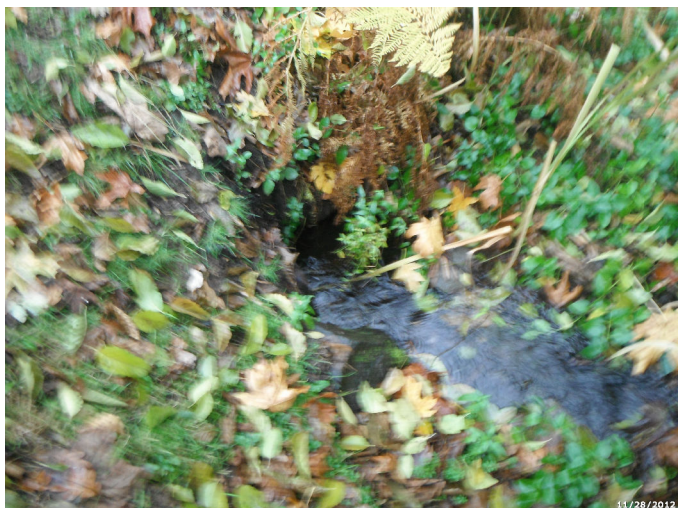
Photo: SPCR_C4_4127 Route: 402-001-0.06
Metal Culvert 60ft long 18in dia. 7ft deep

Photo: SPCR_C4_4128 Route: 402-001-0.06
Metal Culvert 60ft long 18in dia. 7ft deep

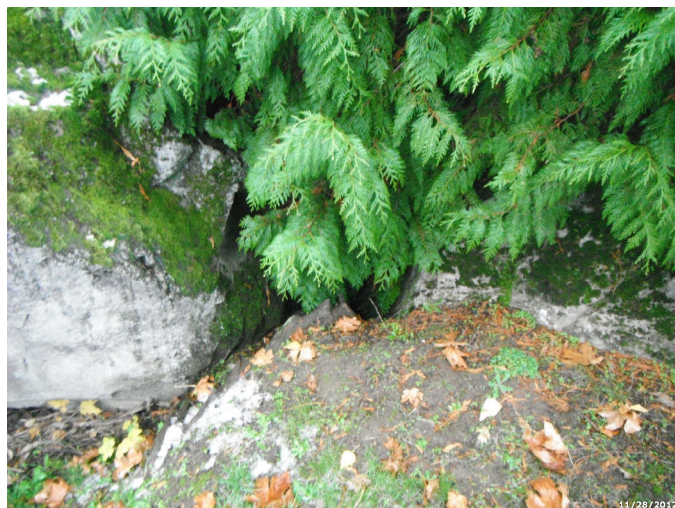
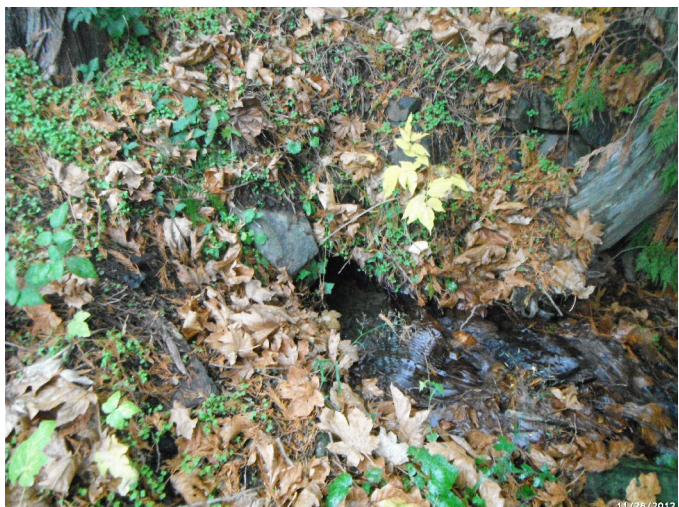
Photo: SPCR_C4_4125 Route: 402-001-0.08
Metal Culvert 40ft long 18in dia. 7ft deep

Photo: SPCR_C4_4126 Route: 402-001-0.08
Metal Culvert 40ft long 18in dia. 7ft deep
